O & M INSPECTION REPORT FOR NAVIGATION PROJECTS  
Honolulu Engineer District  
CEPOH-EC-T

1. Project Name: Kawaihae Small Boat Harbor

2. Date of Inspection: May 3, 2005

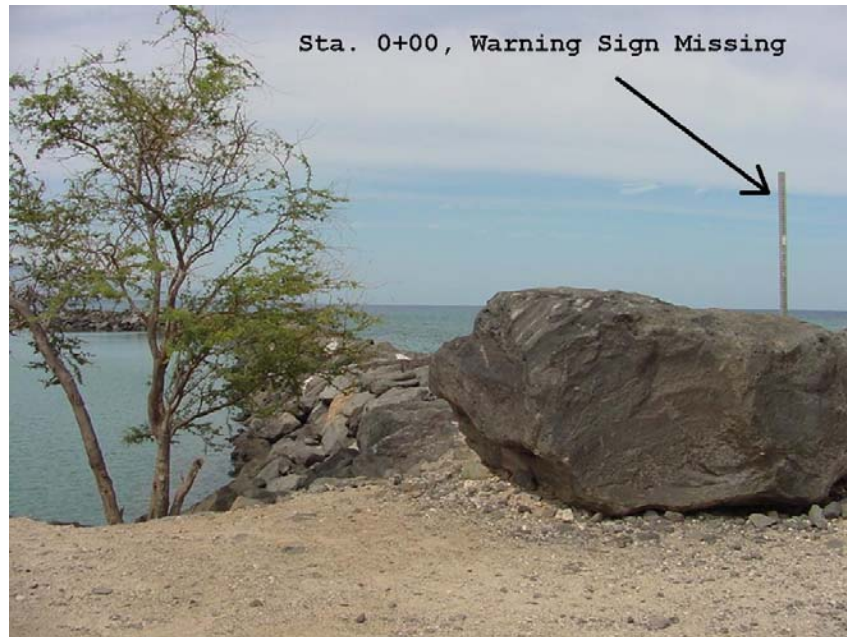
a. Breakwater warning sign missing FY03 Photo.

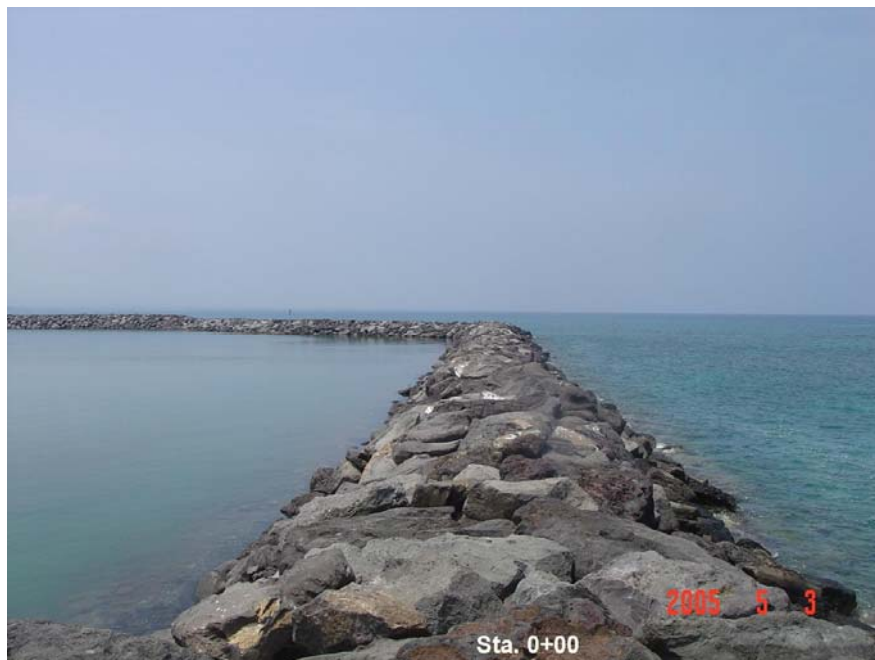
b. Sta. 0+00, Overview photo for reference.

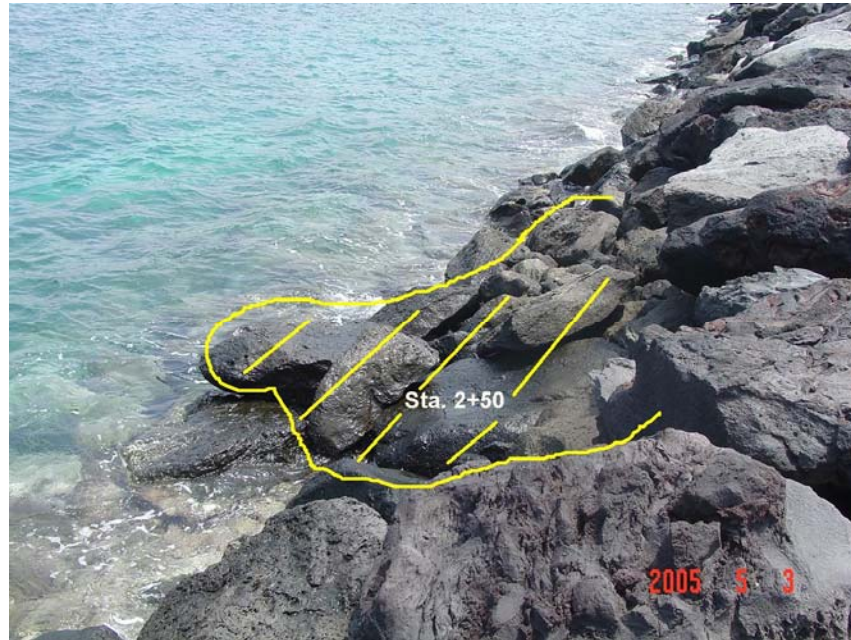
c. Sta. 2+50, OS, Dislodged armor stones on sideslope.

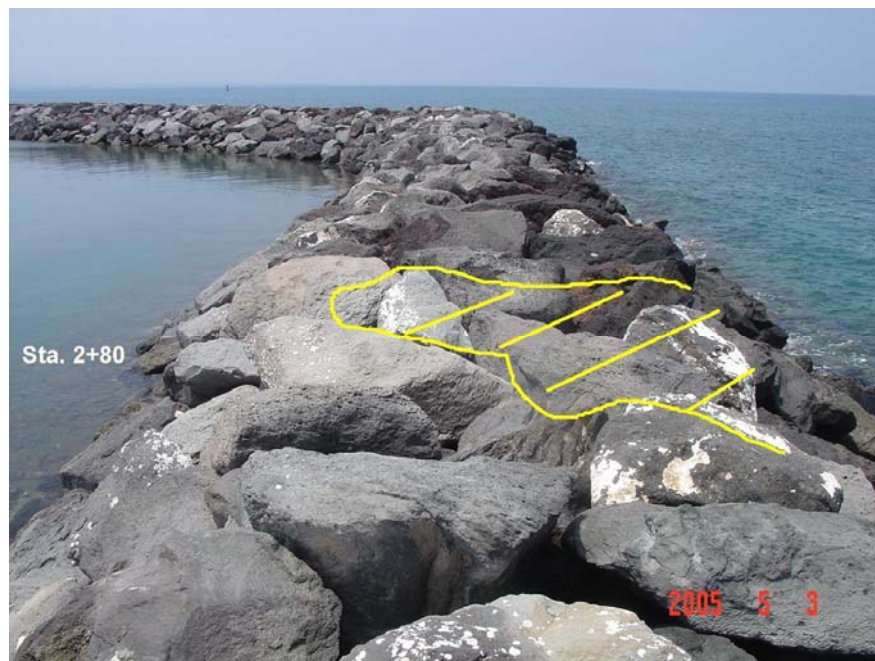
d. Sta. 2+80, OS & HS - Crest, Settling of armor stones approx. 4' deep. Monitor this area.

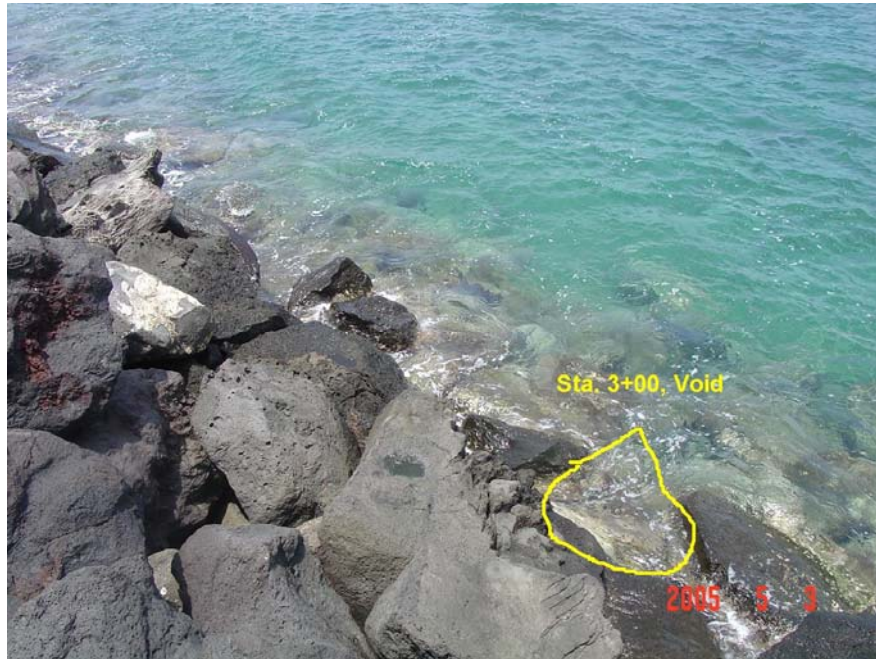
e. Sta. 3+00, OS, Displaced armor stone & exposed underlayer at waterline.

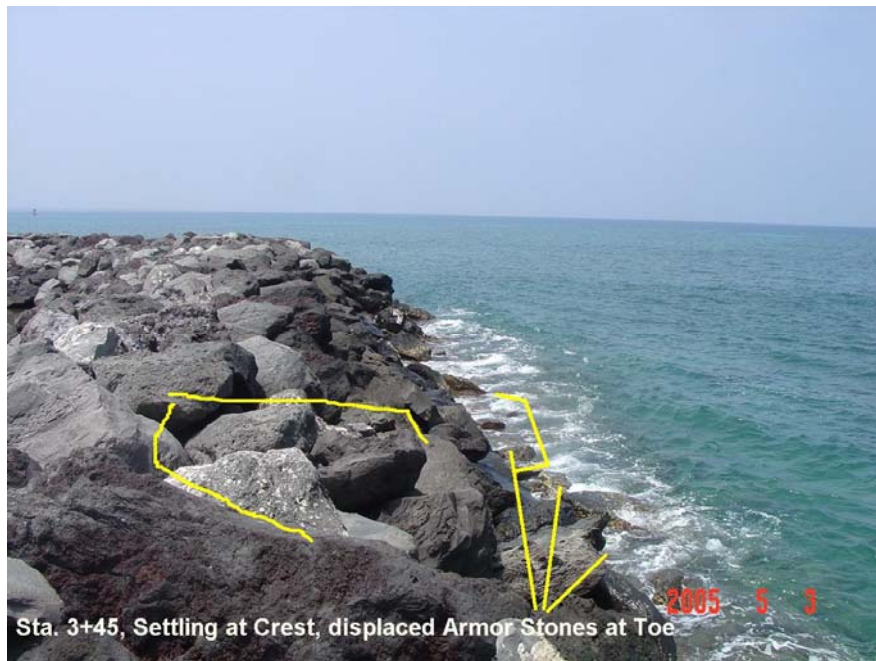
f. Sta. 3+45, Settling at crest, armor stone displacement at toe.

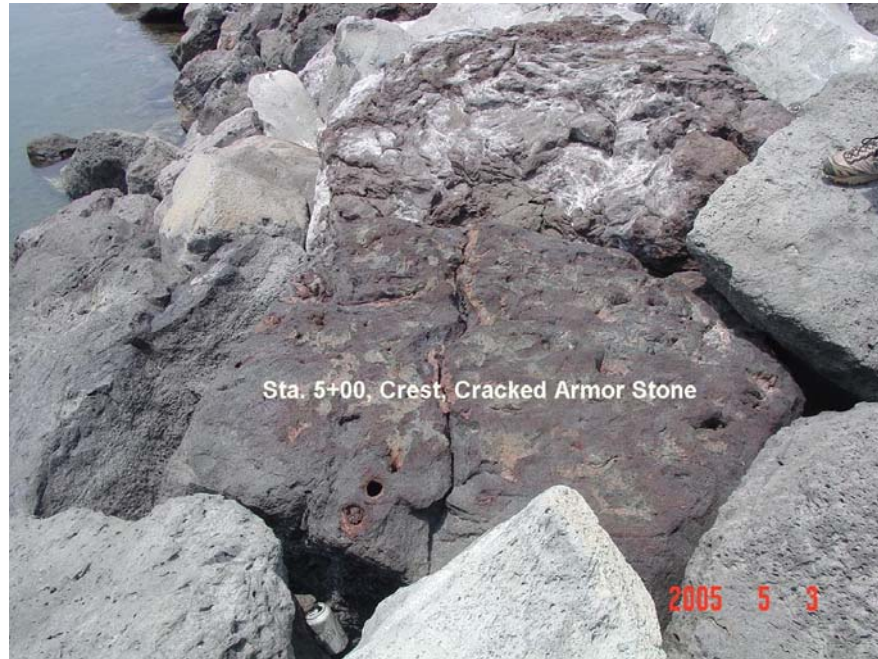
g. Sta. 5+00, Crest, cracked armor stone.

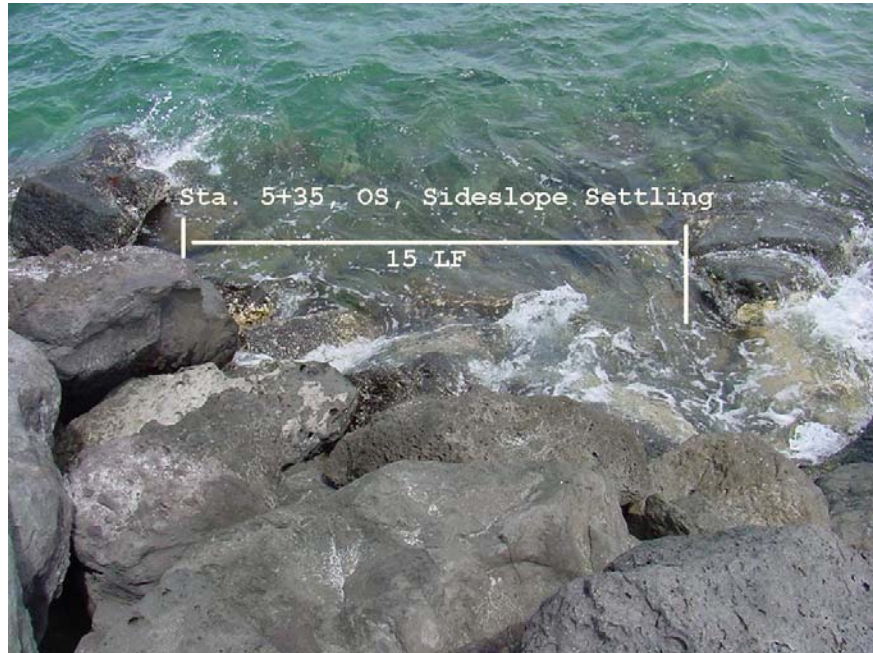
- i. Sta. 5+35, OS, Possible sideslope sliding, dislocated armor stones, void, FY 03 photo.

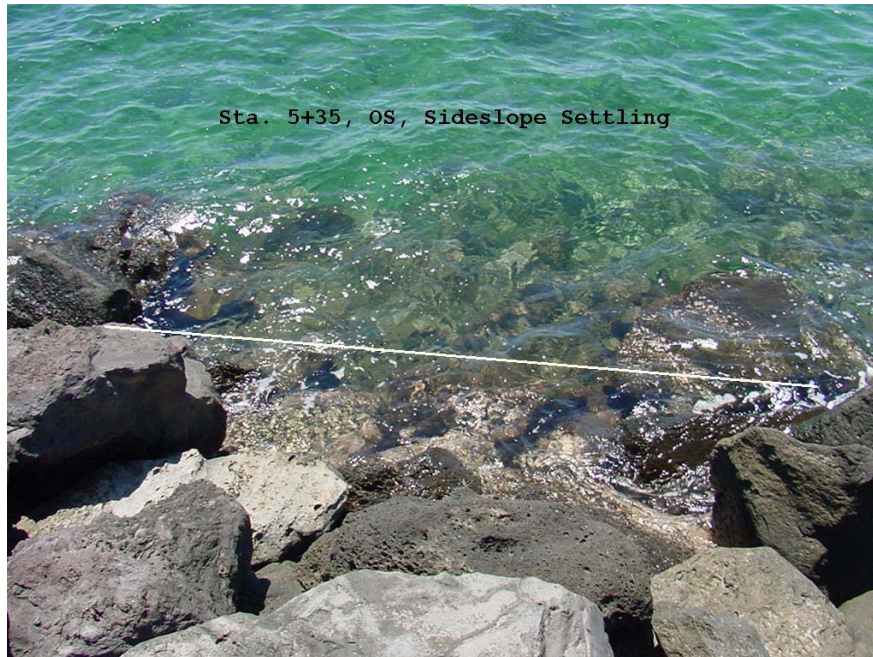
- j. Sta. 5+35, OS, Sideslope settling, armor stones missing, FY 03 photo.

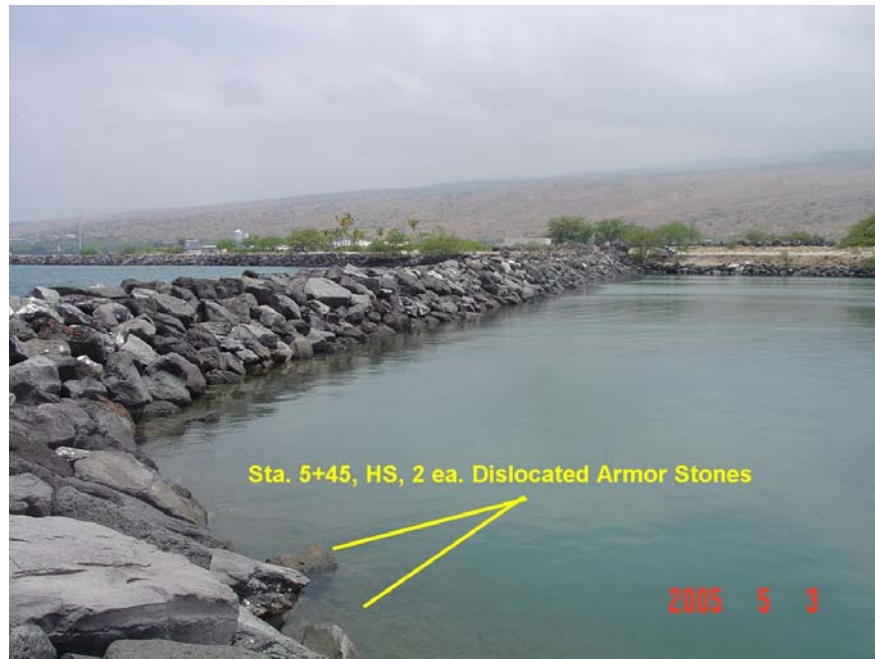
k. Sta. 5+45, HS, 2 ea. Dislocated Armor Stones.

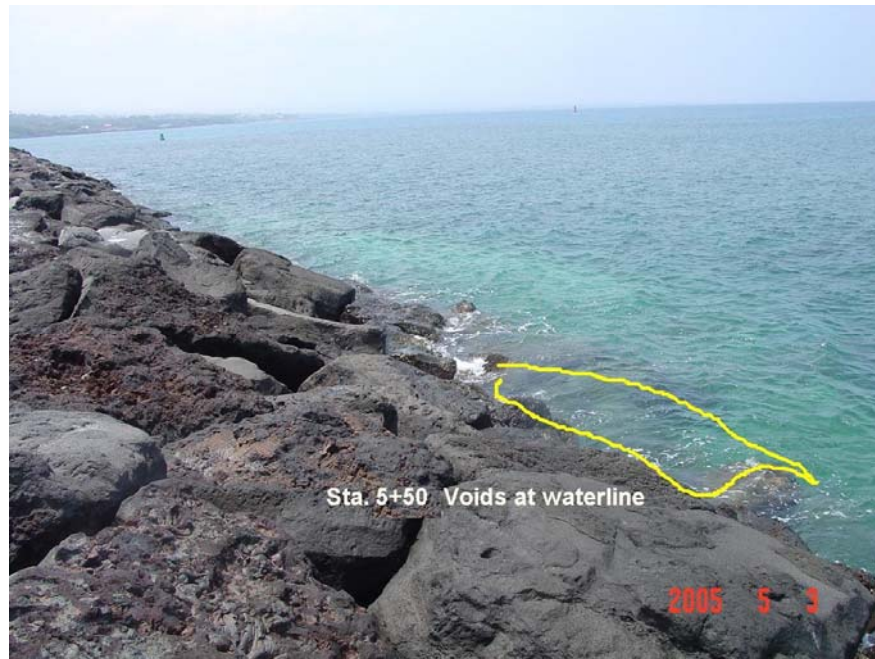
m. Sta. 5+50 - Sta. 5+75, OS, Possible sideslope failure, toe stones missing, void, approx. 20LF.

**NOTE:** Construction QA Report: Sta. 5+43, 6+50, 8+60 to 8+83, underwater inspection report states "...vertical placement, slide potential".

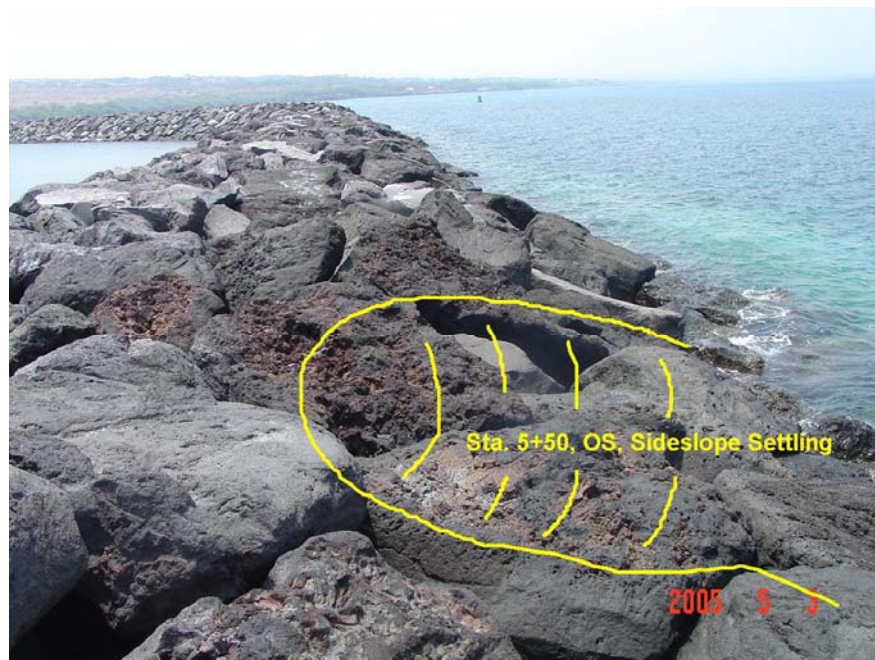
n. Sta. 5+50 - Sta. 5+75, OS, Possible sideslope failure, toe stones missing, void, approx. 20LF.

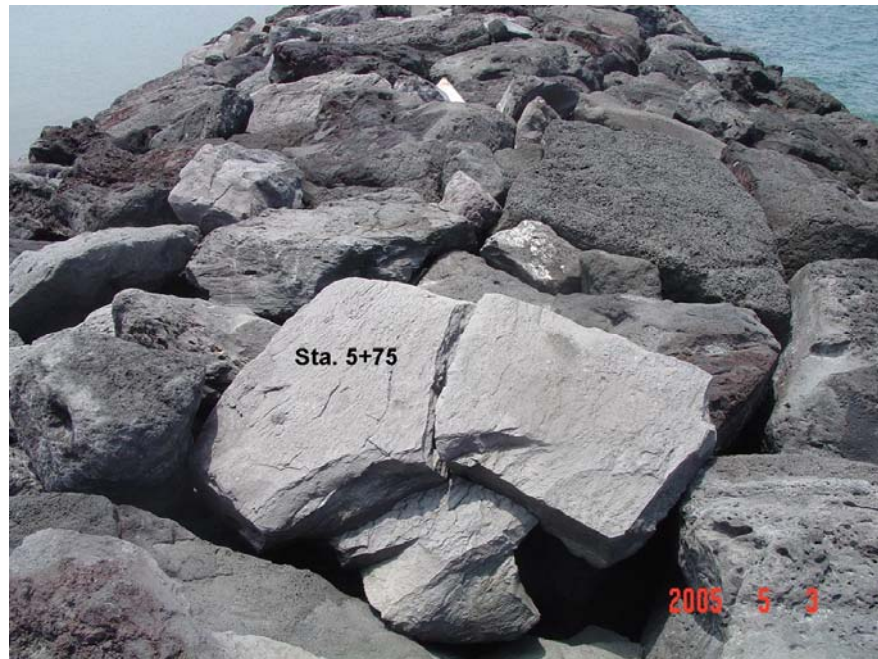
- o. Sta. 5+75, Cracked armor stone at centerline of crest.

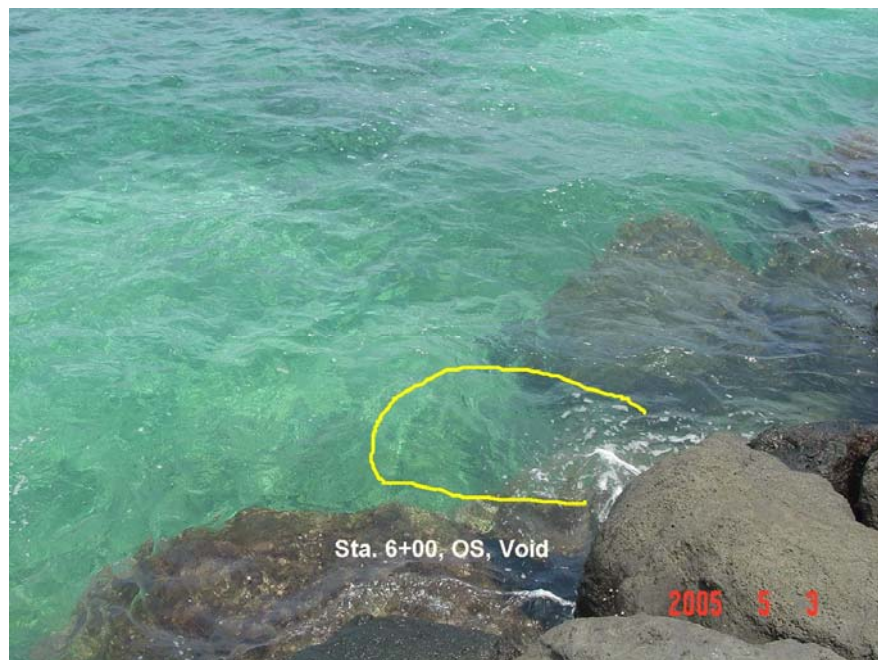
- p. Sta. 6+00, OS, Dislodged armor stone @ toe, cavity/void.

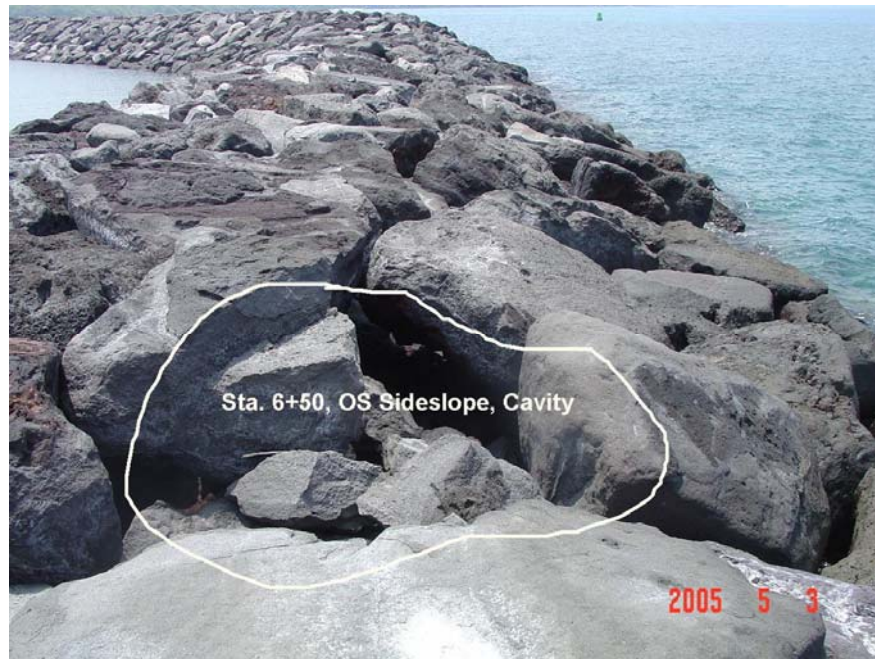
q. Sta. 6+50, OS, Cavity, five foot dia., sideslope steeping.

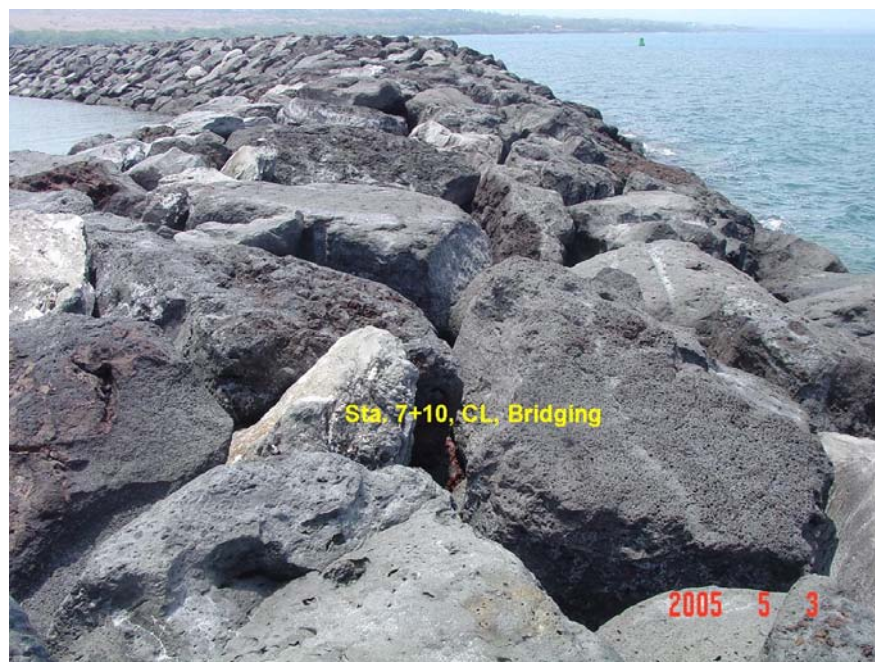
r. Sta. 7+10, OS, Bridging of armor stone, large cavity.

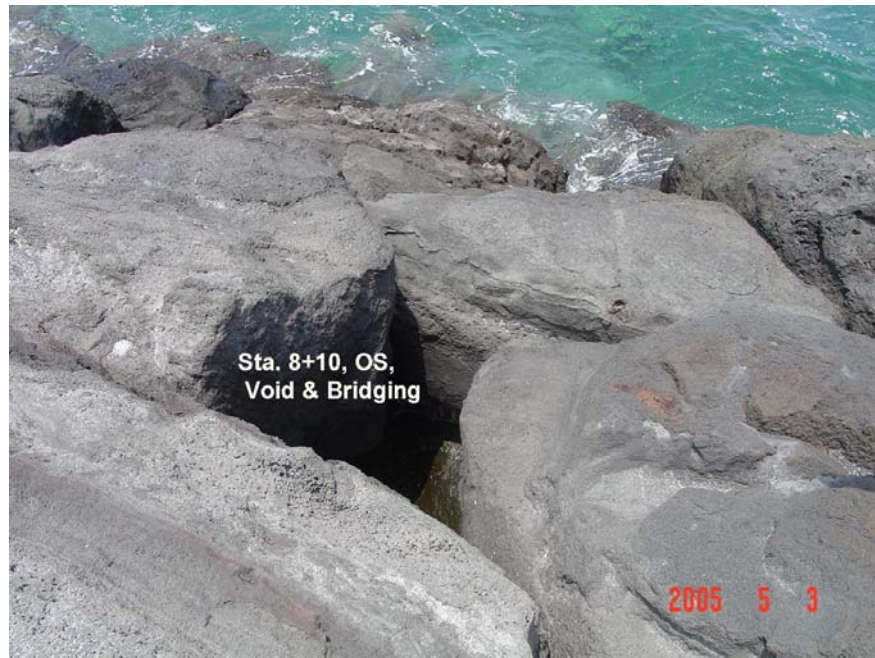
- v. Sta. 8+10, OS of crest, large void and bridging.

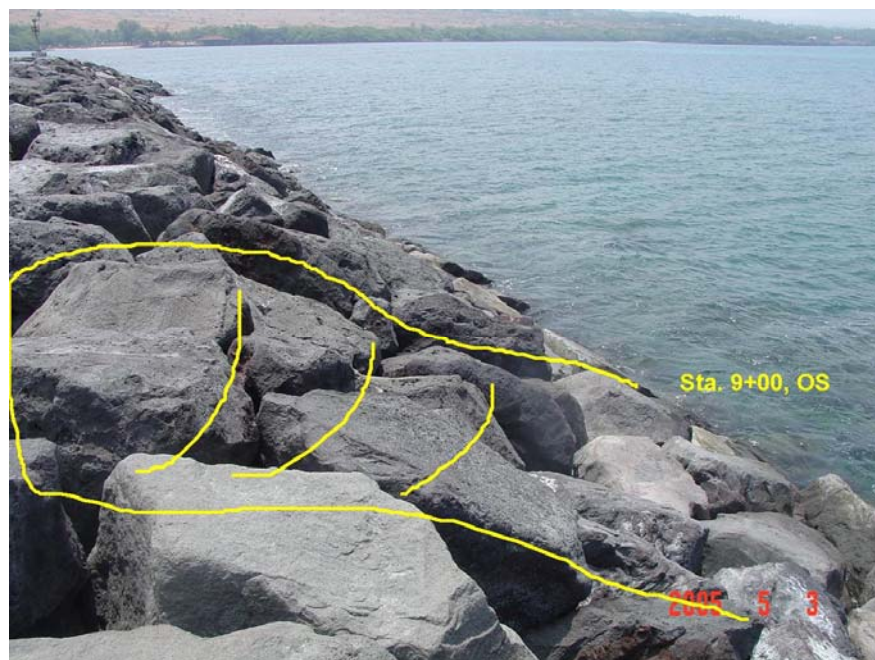
- w. Sta. 9+00, OS, Settling of sideslope.

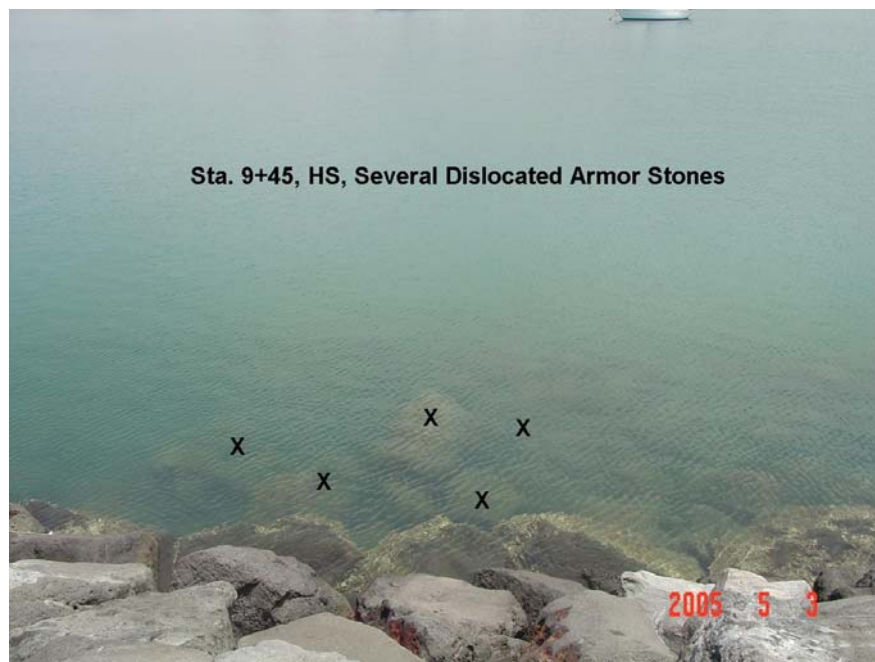
y. Sta. 9+45, HS, Several dislocated armor stones.

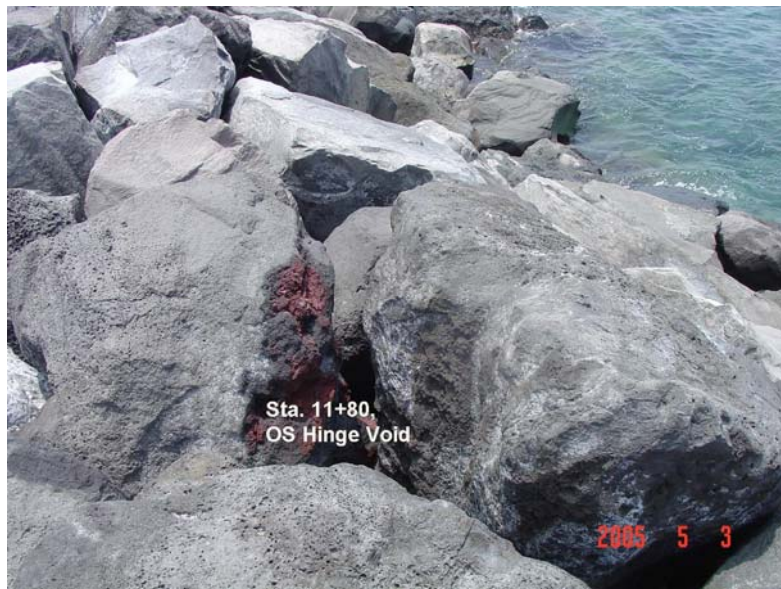
- gg. Sta. 11+80, OS, void at hinge.

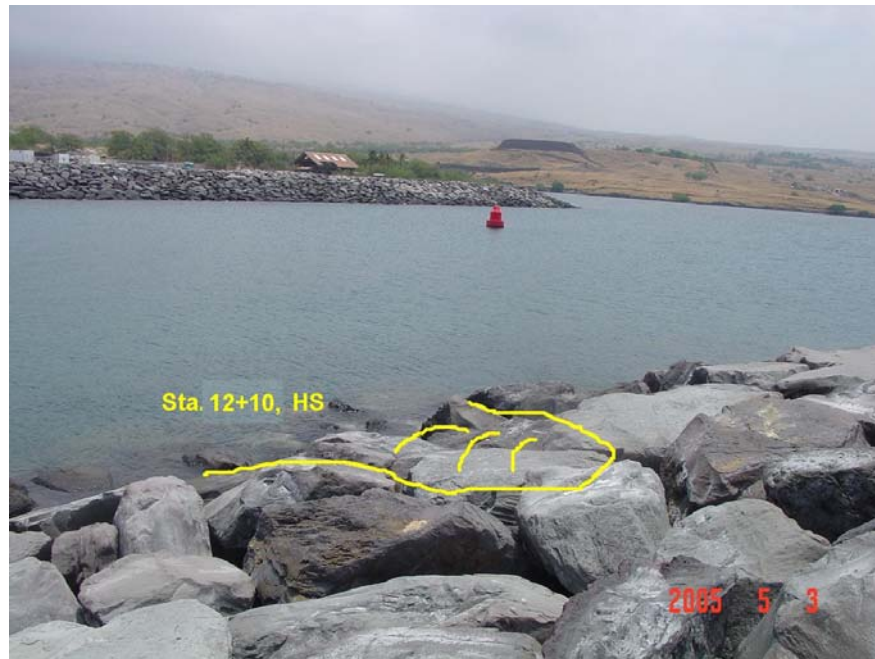
ii. Sta. 12+10, HS Hinge, Settling.

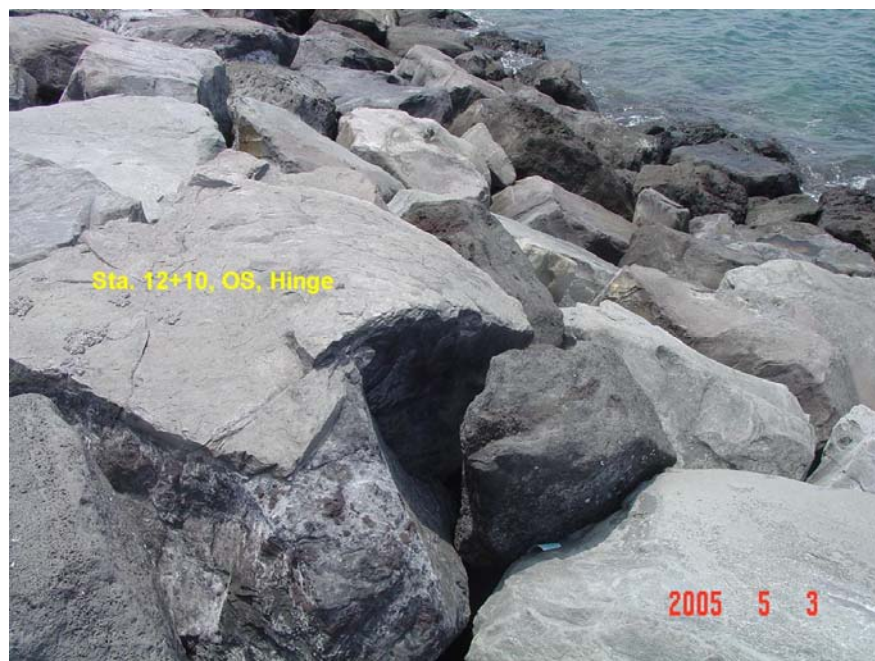
jj. Sta. 12+10, OS Hinge, split armor stone.

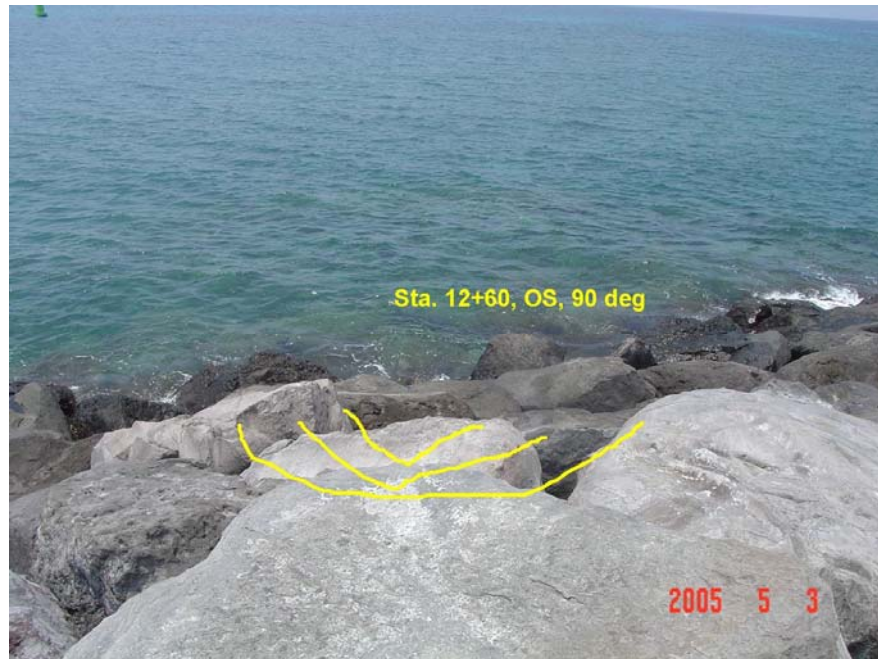
kk. Sta. 12+60, Head, Additional sideslope settling this year.

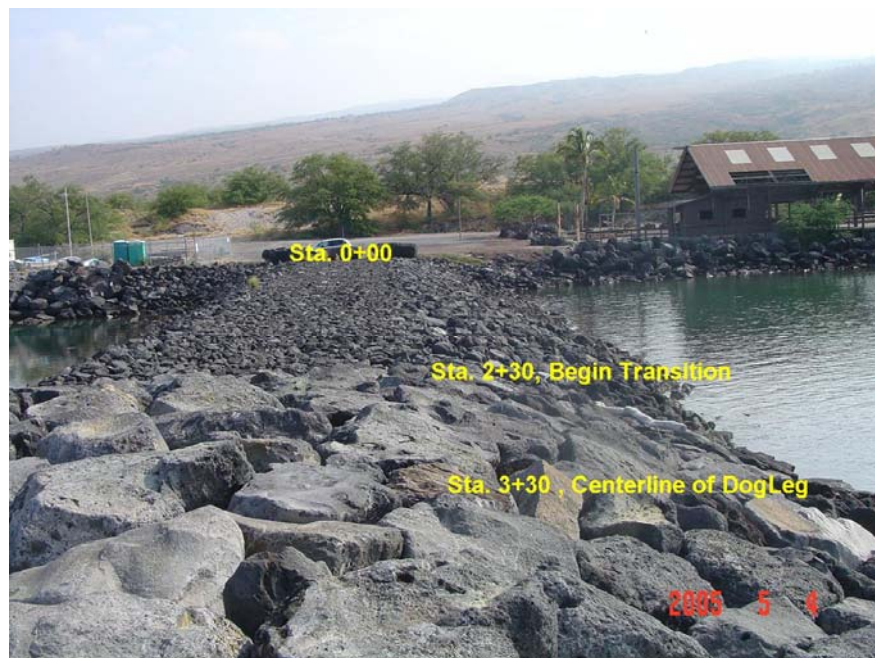
- c. Sta. 2+80 to 4+00, OS, Monitor minor settling on sideslope.

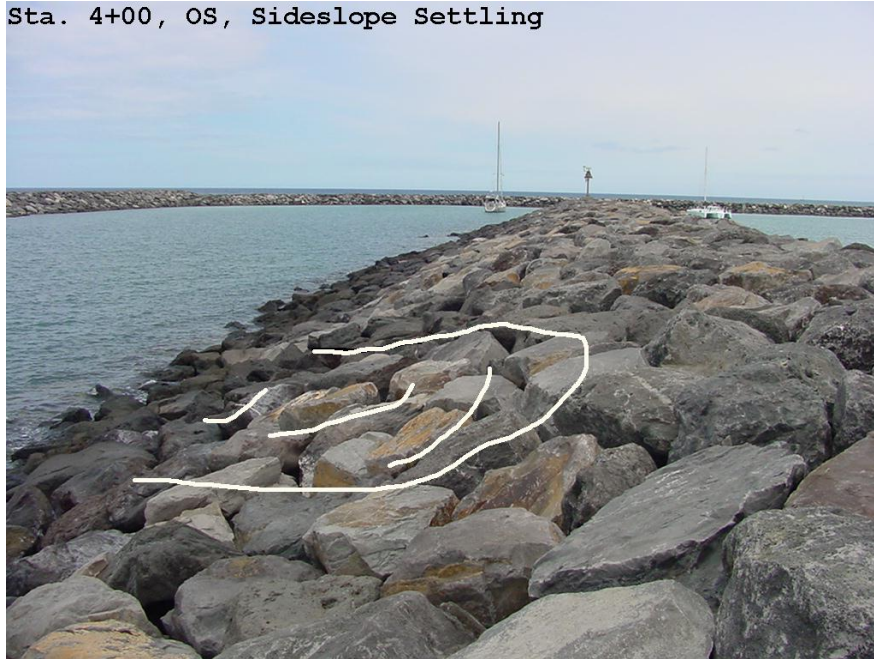
d. Sta. 4+00, OS, Sideslope settling.

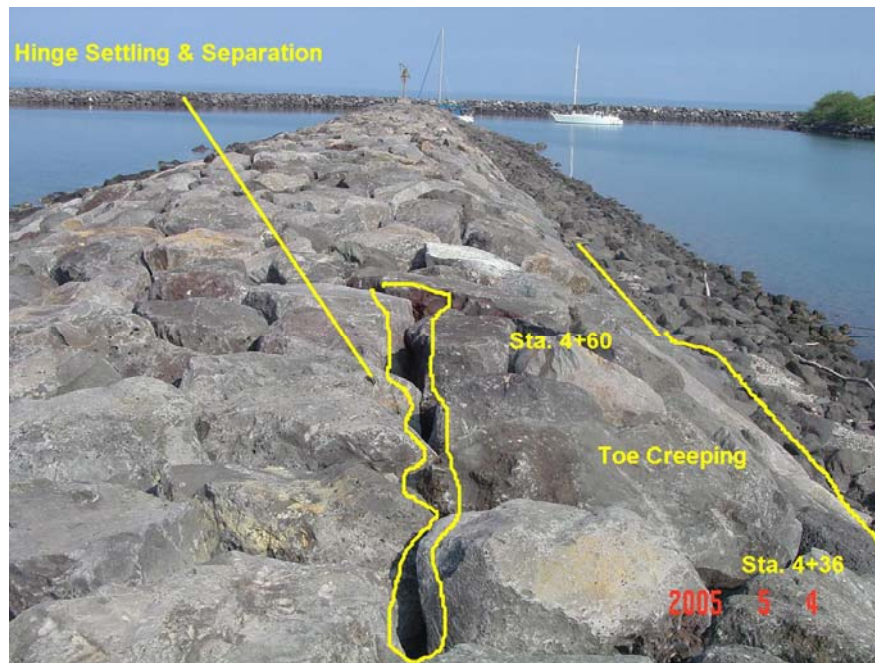
e. Sta. 4+36, OS, Minor settling, area approximately 30' x 40', sideslope.

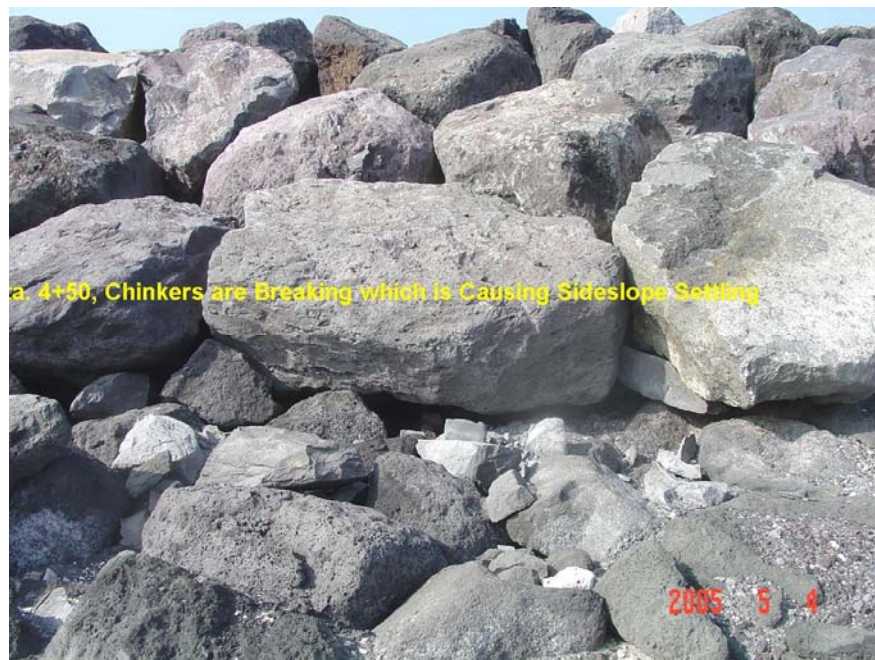
f. Sta. 4+50, HS, Chinkers have begun to break due to weight of armor stone.

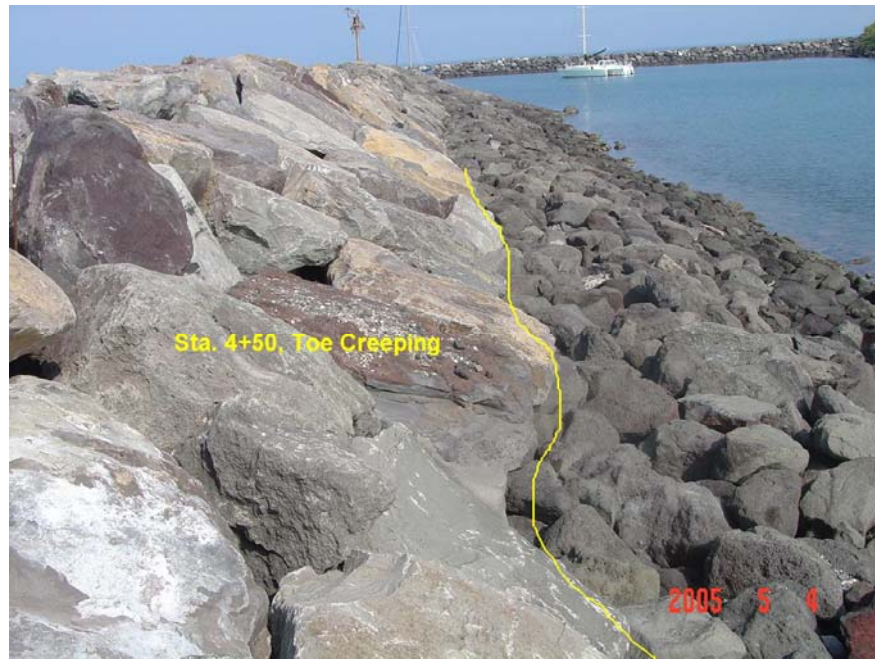
g. Sta. 4+50, HS, Chinkers have begun to break due to weight of armor stone, sideslope beginning to separate @ the hinge and creep @ the toe.

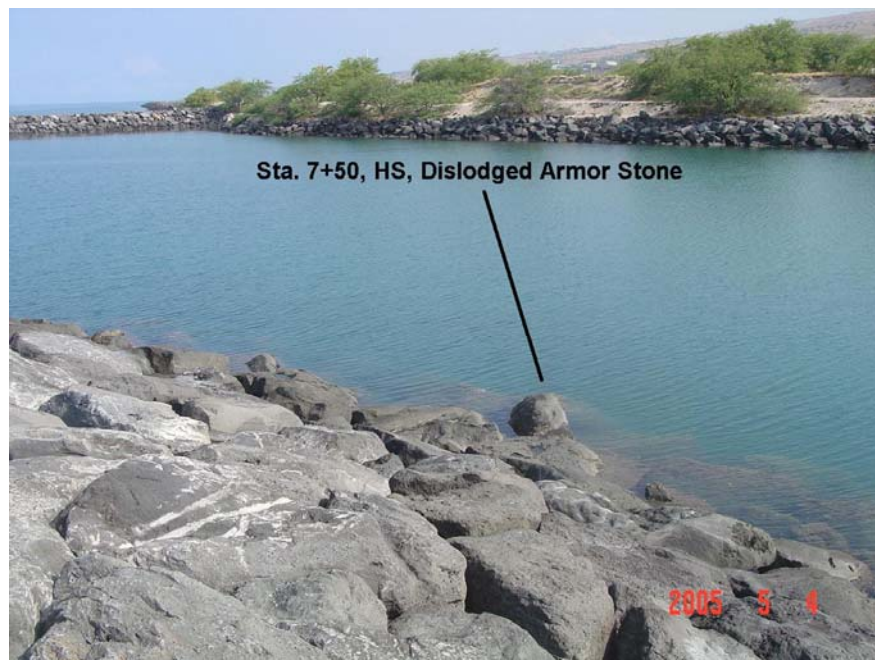
h. Sta. 7+50, HS, 1 armor stone dislodged.

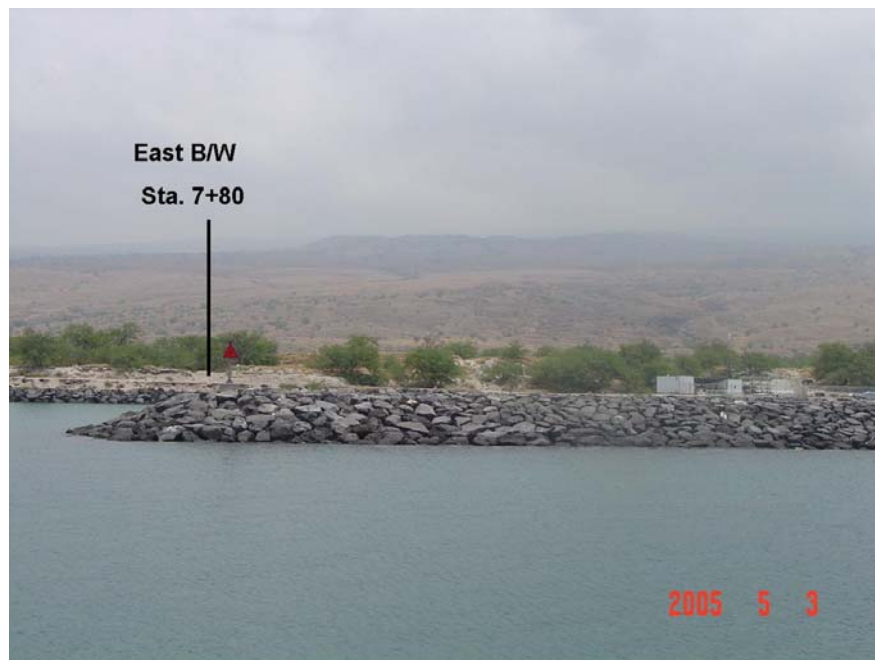
- m. Sta. 7+80, HS of head, 1 ea. armor stone dislodged at the toe small void.
